MATERIALS AND RESEARCH DEPARTMENT
CALIFORNIA DIVISION OF HIGHWAYS

FINAL (20 YEAR) REPORT
ON
THE CORRUGATED METAL CULVERT FIELD TEST
STARTED IN 1929 - 1930

Report by Thos. E. Stanton
Materials and Research Engineer
January, 1951

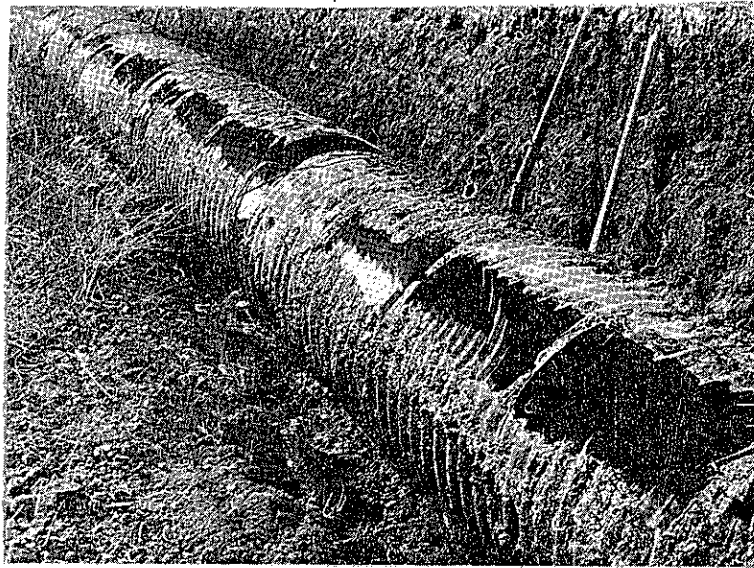
Periodical inspections were to be made and a tentative arrangement agreed upon to do this semi-annually. The first inspection was made $7\frac{1}{2}$ months after installation and sets Nos. 15 and 16 in Amador County were found to be holed through due to the corrosive action by seepage waters from old copper mine tailings. These culverts were then turned on the quarter and reinstalled (See Figure No. 5). Monthly inspections were than made on these two sets.

which is very destructive to metal pipe. Figure No. 5 shows the conditions of the pipes when the first inspection was made $7\frac{1}{2}$ months after installation. Following the discovery of this condition, the pipes were turned on the quarter and inspected monthly. Under the existing conditions, it was found that both galvanized and black sections had a life span of only $4\frac{1}{2}$ months.

The above photograph shows the condition of the metal in sets No. 15 and 16 installed in Amador County seven and one-half ($7\frac{1}{2}$) months after installation.

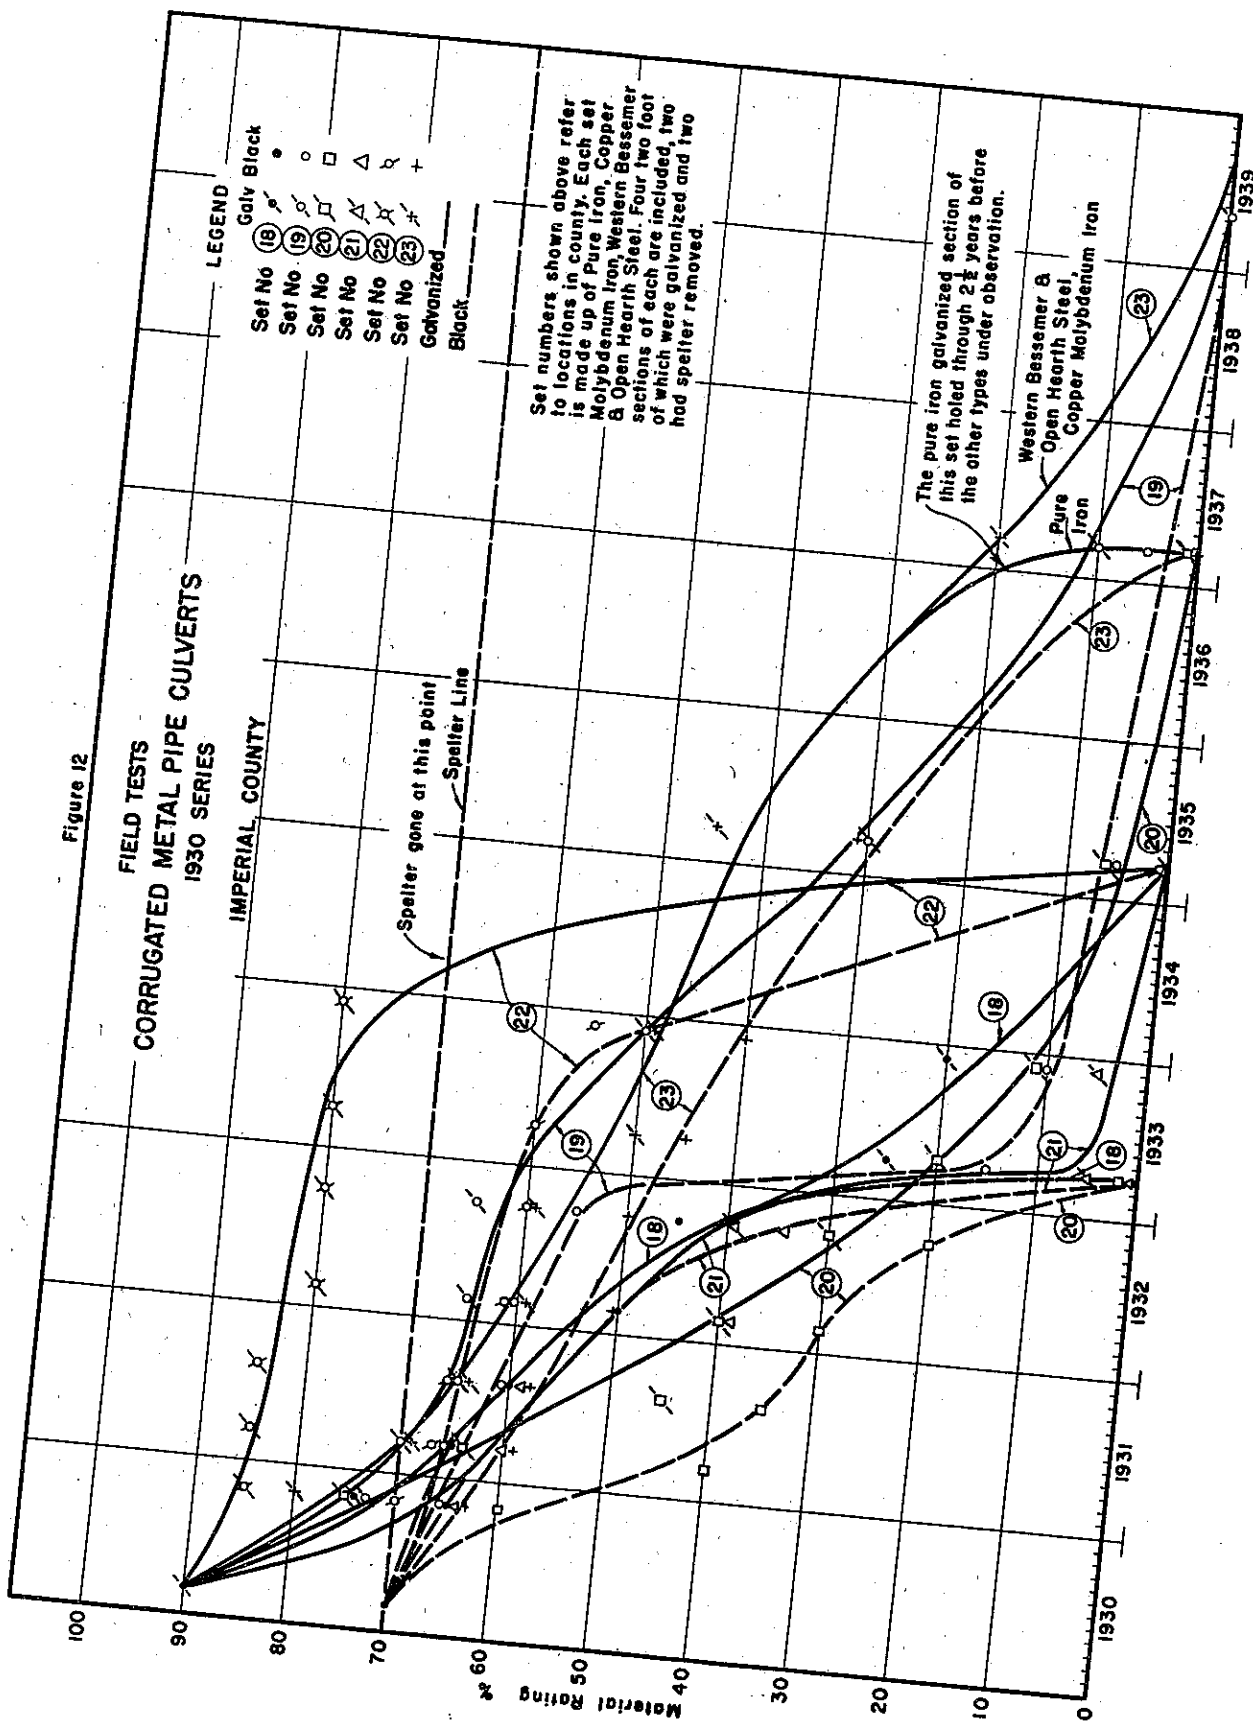
Figure 13

The pure iron galvanized section of this set holed through 2 1/2 years before the other types under observation.
